STATE OF CONNECTICUT

CONNECTICUT SITING COUNCIL

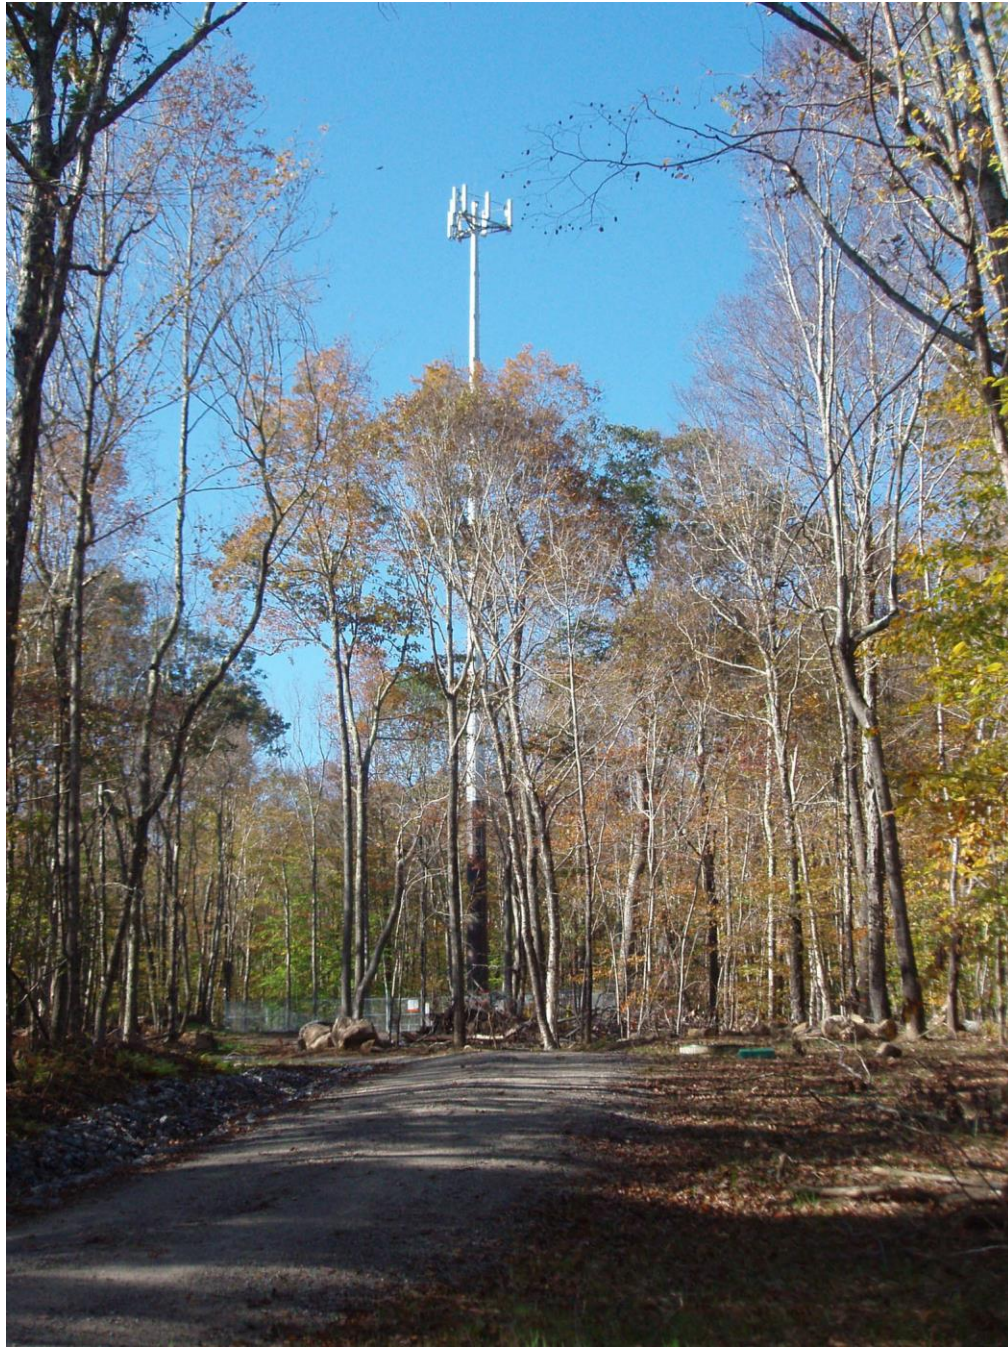
View of base compound
