## Restored fishway in Cornwall opens habitat for trout

Tuesday, September 16, 2014

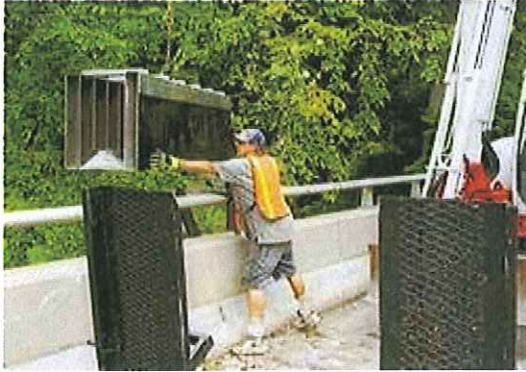
A crew worked for the better part of an afternoon lifting and lowering 450-pound aluminum units into a 120-foot long concrete box culvert, where workers secured the pieces under the bridge carrying Route 4 across the brook.

Jastremski said the [new Alaskan Steeppass units](#) were installed inside the existing fishway, creating an extremely durable baffling system that will maintain velocities that fish can handle as they move upstream. The restored fi

An original fishway at the same site was installed in the 1990s, but it was made of old wooden baffles and as the steep, violent stream carried boulders, the old fishway deteriorated over the years, Jastremski said.
