COMMUNITY
connectivity program

Bridge Road (Route 82) between Route 154 and East
Haddam – Road Safety Audit

August 9, 2016

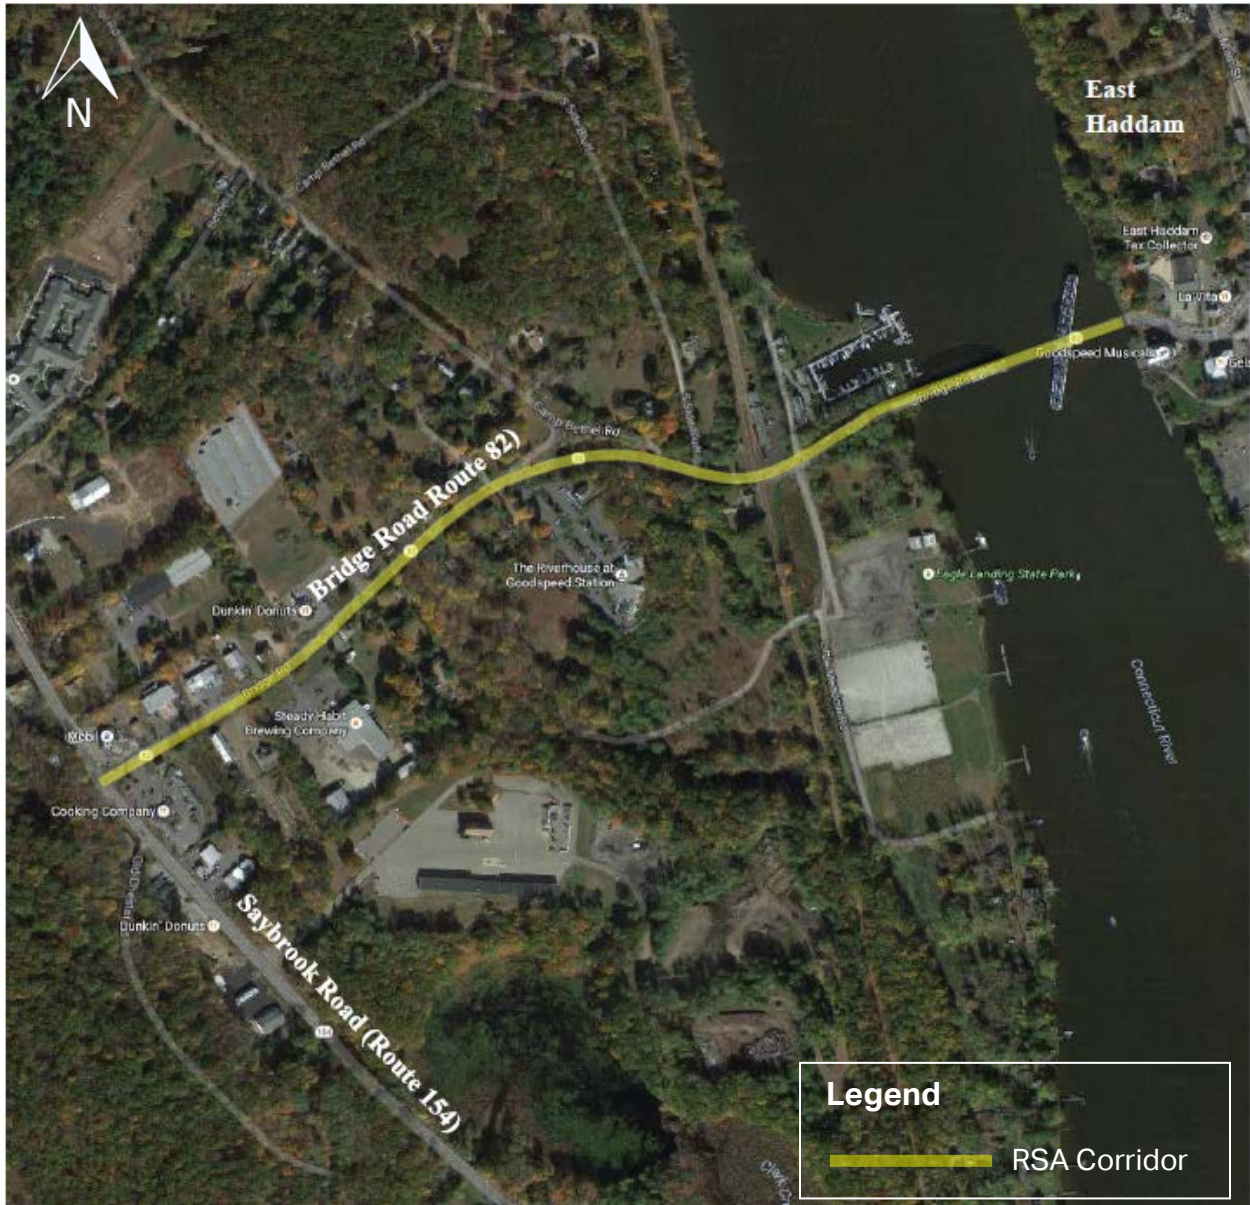
Figure 1. Bridge Road (Route 82), Haddam, East Haddam

The RSA site is the section of Bridge Road between State Route 154 and East Haddam (Figure 1). The Average Daily Traffic (ADT) on Bridge Road is between 10,700 and 11,300 vehicles per day (vpd). Bridge Road consists of a single lane in each direction, separated by a double yellow center line. There are striped shoulders on each side of the road, with widths that vary from less than one foot to approximately six feet.

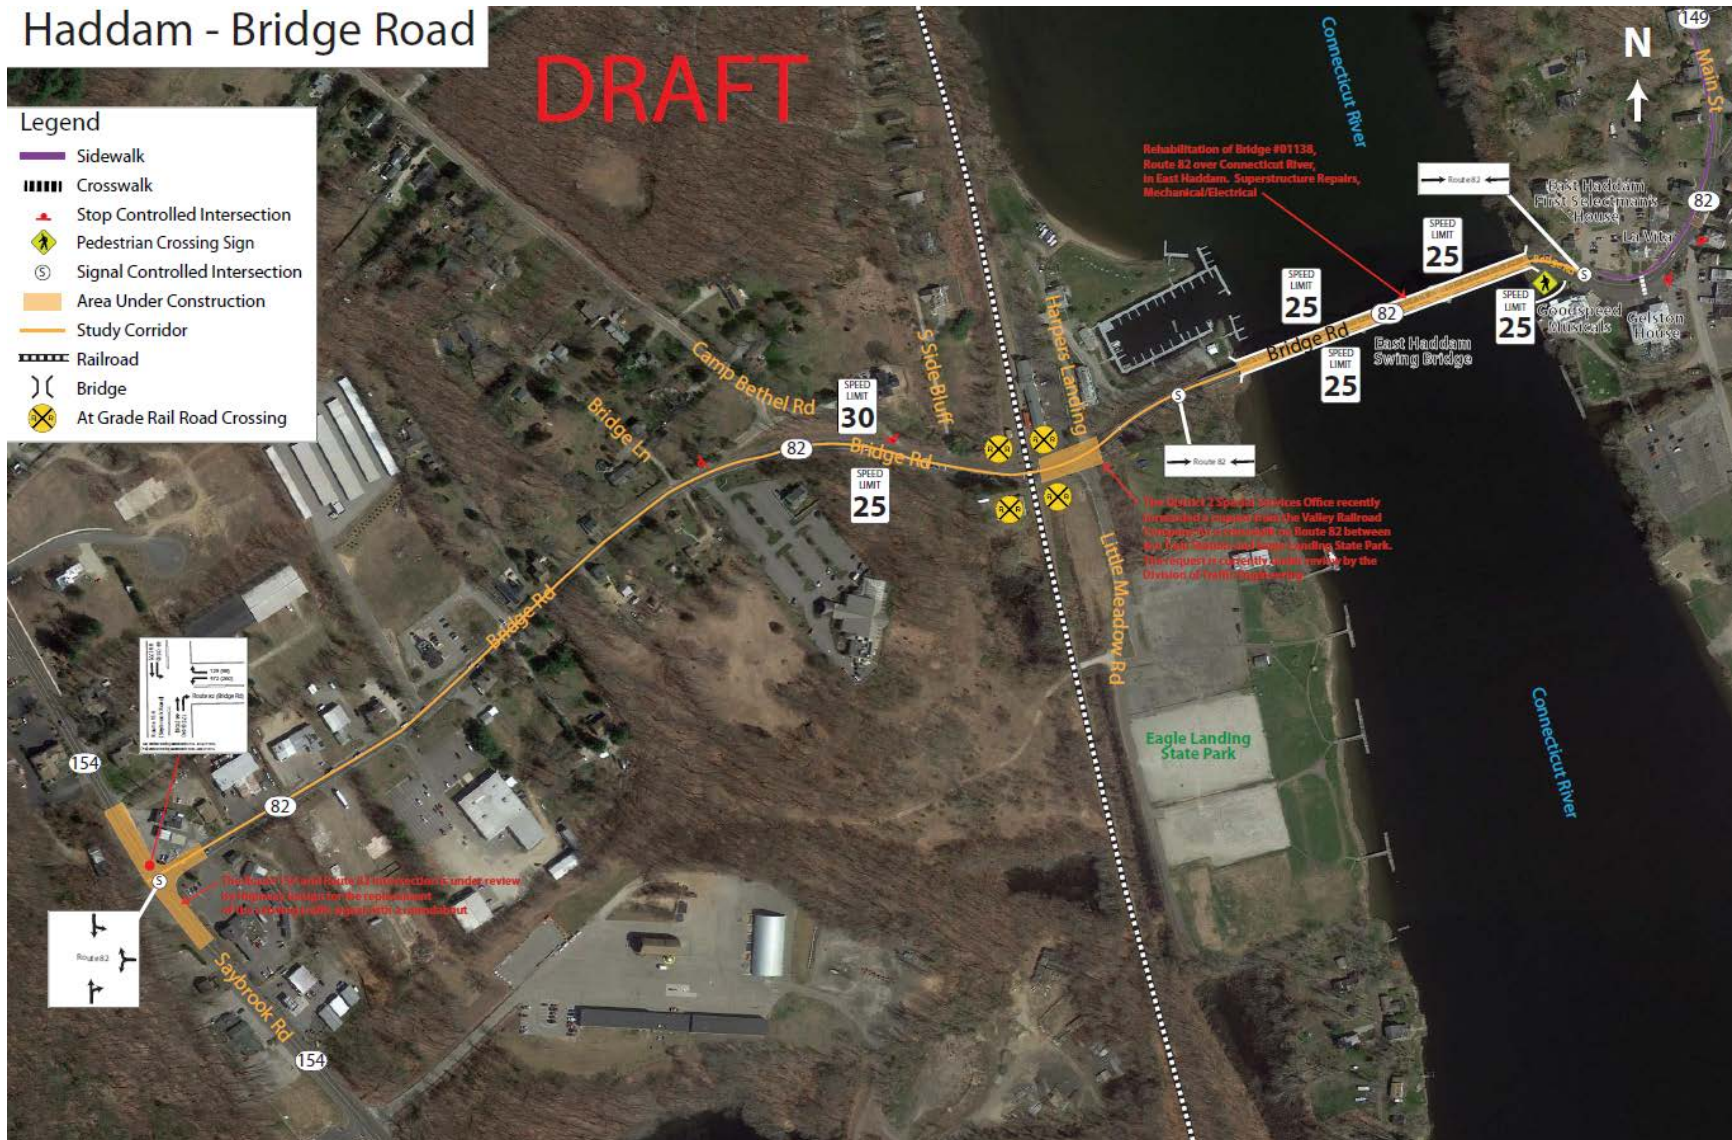
Figure 4. Bridge Road Geometrics

Figure 4 shows roadway geometrics on Bridge Road in the study corridor. As shown in Table 3 below, Bridge Road and the East Haddam swing bridge have no sidewalks. The bridge has 10.5-foot lanes in both directions. There are one to two-foot wide shoulders on both sides of the bridge and shoulders between one and six feet wide on other portions of Bridge Road. The narrow shoulder and lack of sidewalk on the bridge is a concern for both towns as pedestrians cross the Connecticut River daily.

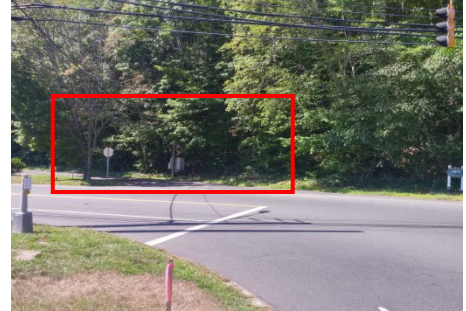
Figure 5. Stop Sign Controlled on Old Chester Road Approach Near Signal

- Haddam has a geometric concern at the three-way signal (Route 82 and 154) and its relationship to the stop sign at the Old Chester Road approach, due to its close proximity to the signal.

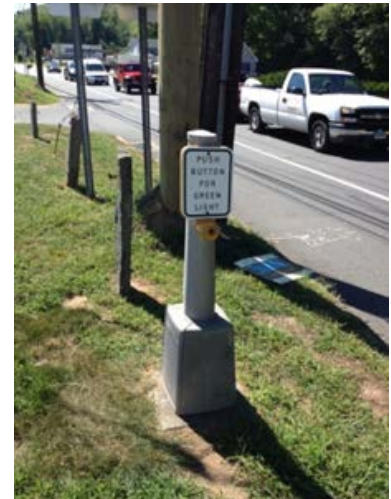
Figure 6. Pedestrian Button and Wide Shoulder on Route 154 Northbound Approaching Bridge Road

- The intersection of Route 154 and Route 82 has wide striped shoulders that act as a right-turn lane from Route 154 northbound onto Route 82 and from Route 82 westbound onto Route 154. Although this striping increases traffic capacity, it creates an obstacle for cyclists when their shoulder is taken away by vehicles. This intersection is also in need of crosswalks.

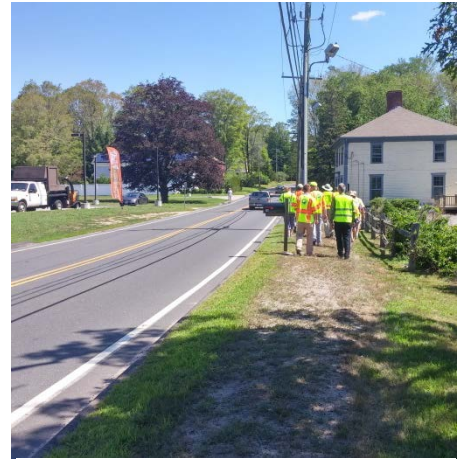
Figure 7. Worn Path in Front of Tylerville Country Market on South Side Bridge Road

- There is a worn path in front of Tylerville Country Market (Figure 7), although there is no sidewalk.
- If a sidewalk is constructed on the south side:

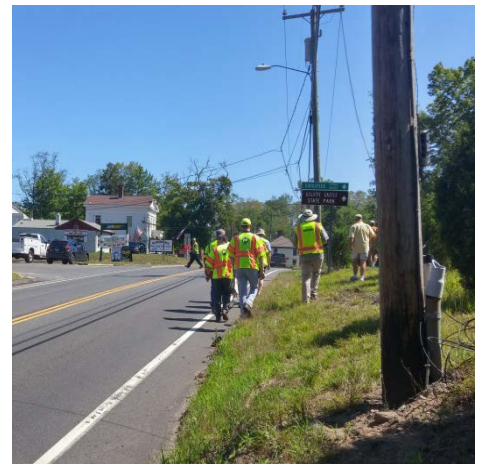
Figure 8. Slope Issue on South Side of Bridge Road

- For the most part, there is not a steep grade except at the Fireworks Hearth & Home driveway.
 - A sidewalk may take away some parking from the business owners.

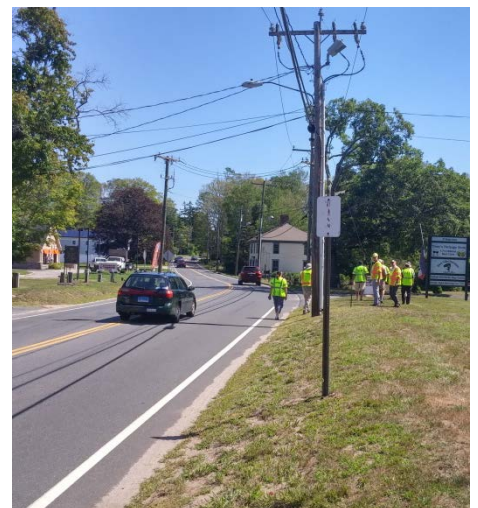
Figure 9. South Side of Bridge Road With Utility Poles

- Not sure how much Right of way is available
- The Town should check the ordinance that addresses who is responsible to maintain sidewalks. Haddam could change the ordinance if needed so that the Town maintains sidewalks if business owners object.
- Haddam would prefer a sidewalk with a grass or landscaped buffer between the sidewalk and roadway.
- In order to provide better bike accommodations on Route 82 the Town could stripe five-foot shoulders or change the Town policy to allow bike riders to use a future sidewalk.
- Travel lanes could be restriped to 11 feet to increase shoulder width.

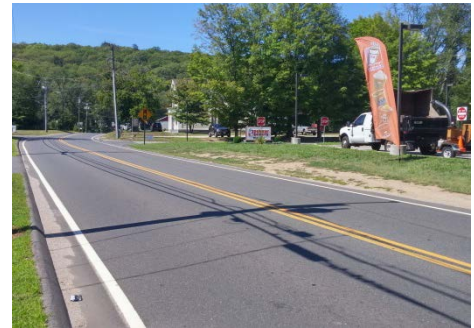
Figure 10. Westbound Bridge Road in Front of Dunkin Donuts

There is no on-street parking (Figure 10).

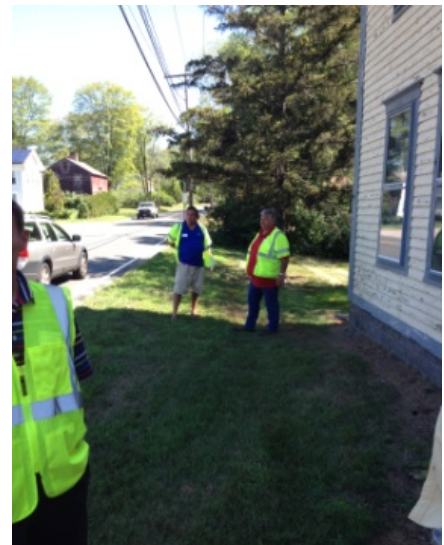
Figure 11. Shailerville House

- 85 Bridge Road is the historic Shailerville House. It is located close to road, but there is still enough room for a sidewalk (Figure 11).
- There is a contaminated water issue in this area.
- Department of Energy & Environmental Protection (DEEP) State Land (Figure 12):
 - The entrance gate is opposite 80 Bridge Road.
 - The land could be converted to a multi-use trail to link to Eagle Landing State Park.
 - If this is converted to a trail the Town would still like to continue the sidewalk on Route 82.

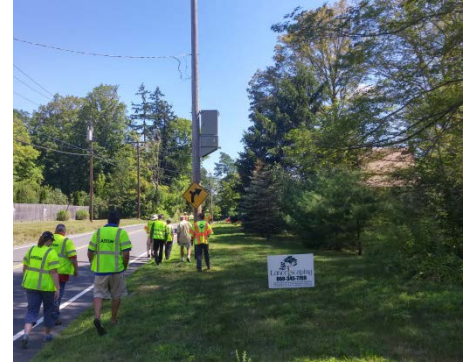
Figure 13. South Side Route 82 Before Riverhouse

- There is a sharp curve and steep grade on Route 82 that limits sight distance for vehicles approaching the Riverhouse and Camp Bethel Road (Figure 13 and Figure 14).
- On the west side of the Riverhouse driveway there is a wide turn radius and the curbing stops, but the pavement extends outside of the driveway.
- Camp Bethel Road sign across from Riverhouse driveway is partially blocked by branches (Figure 15).
- There are tree branches on the south side of the road that may reduce the sightline on the sharp Route 82 curve (Figure 14).

1. The Local Traffic Authority (LTA) can request the CTDOT to trim branches that limit sightlines and block signage on Route 82 at the Riverhouse driveway.
2. Begin developing concepts for the new sidewalk on the south side of Route 82.
3. Install share the road signage (Figure 20) for bikers or signs indicating that bikes can take the travel lane on the bridge. The LTA to send letter to CTDOT, OSTA (Office of State Traffic Administration) or maintenance.
4. Simplify the current wayfinding signage in the area because too much signing could be overwhelming. Consider developing a branding logo for "The Haddams" area. The LTA can request wayfinding signage with OSTA (Figure 21).

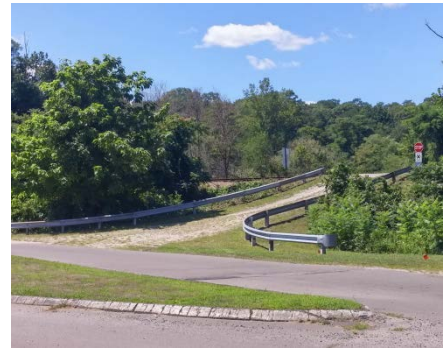
Figure 16. Path to Valley Railroad Stop

- DEEP and Valley Railroad are working to extend rail service further north.
- The railroad trips could generate significant foot traffic between Eagle Landing and Goodspeed Station gift shop.
- The worn path with a steep slope leading to the railroad stop in the parking lot is not ADA compliant (Figure 16).
- Valley Railroad may provide shuttle buses across the swing bridge until a pedestrian connection is available.
- The large parking lot is used to serve River Quest boat excursions.
- RiverQuest has about 11,000-13,000 visitors per year.
- DEEP is looking to develop a Master Plan for this property. A new boat ramp is proposed. If this is

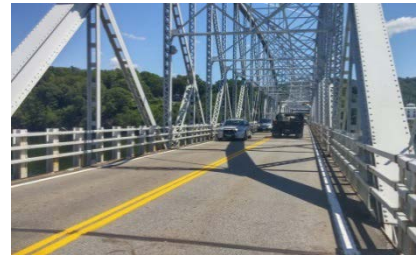
Figure 17. Swing Bridge Roadway Cross Section Looking East

- The travel lanes are 10.5 feet wide (Figure 17).
- The shoulders are two feet wide on the south side and one foot wide on the north side.
- The State is looking at options for providing a pedestrian facility including a cantilever walkway on one side of the bridge. There is a steep drop off on the south side which may restrict a new sidewalk. Other options such as a boardwalk on piles, etc. would have to be considered (Figure 18).
- There was a significant amount of heavy truck traffic during the short time spent at the swing bridge.
- There is limited sightline at the west end of bridge due to the horizontal alignment of Route 82 (Figure 19).
