DESIGN FLOOD MEMORANDUM

RE: Design Flood Memorandum
Mill River District Shoreline Analysis
City of New Haven
CNH Project No. 15-195-21
RTG Project No. 15103.00

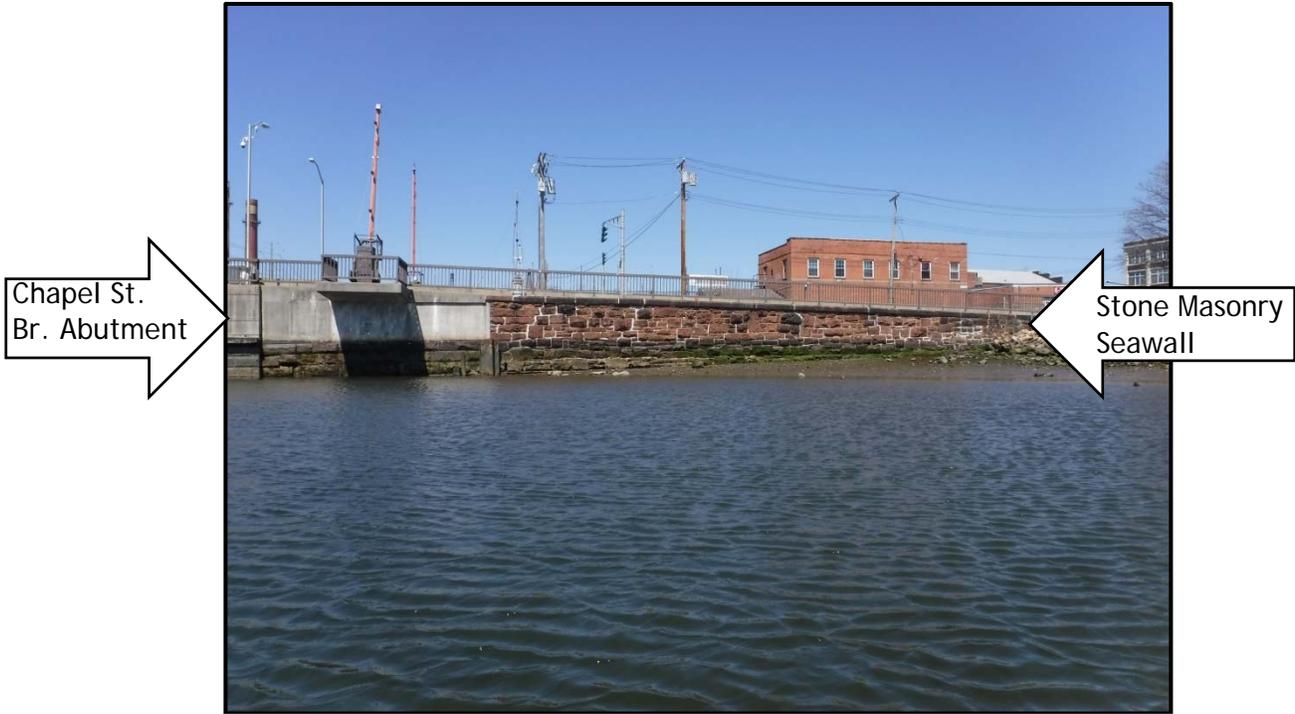
Photo No. 5:
Chapel Street stone masonry seawall, looking north,
photo taken April 14, 2016.

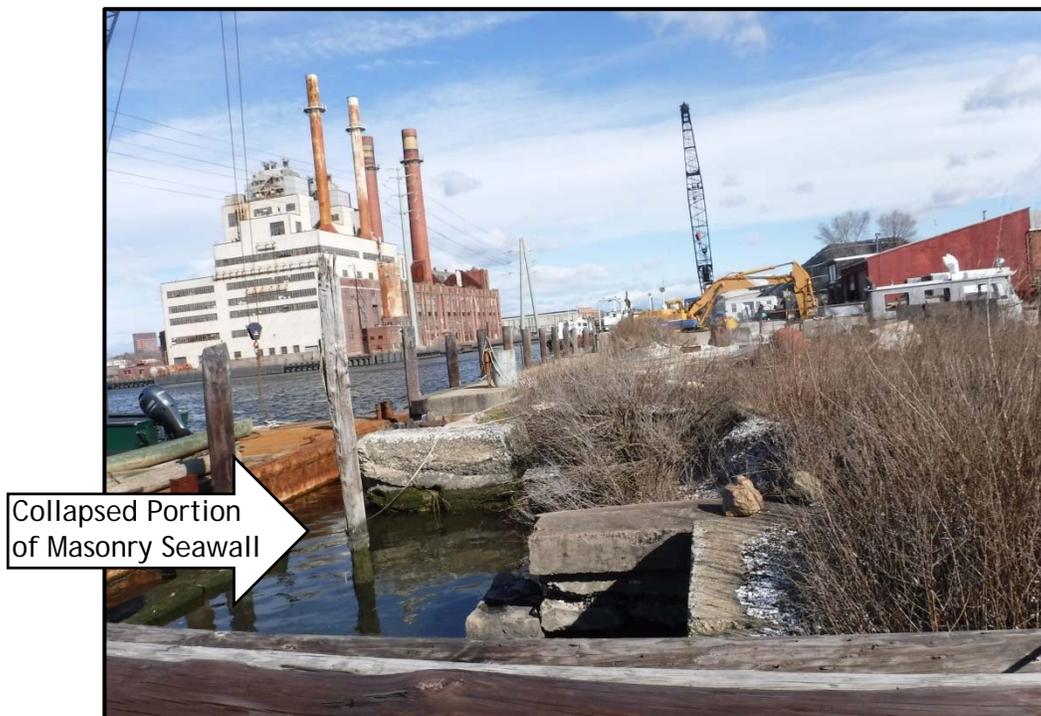
Photo No. 8:
Stone masonry seawall along Hillard Bloom Shellfish, Inc.,
looking north, photo taken March 18, 2016.

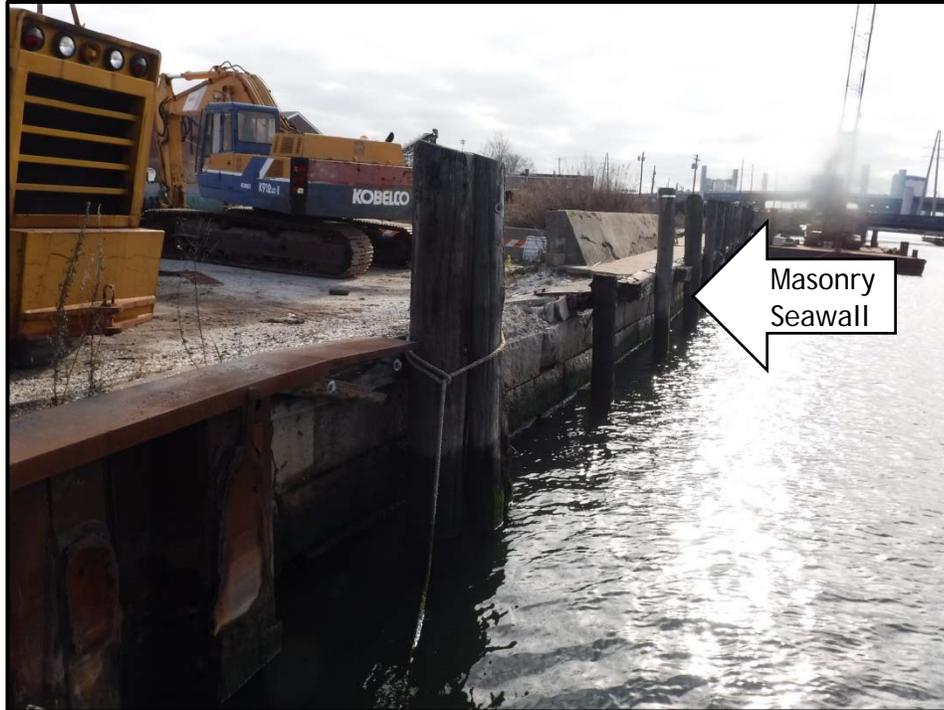
Photo No. 9:
Stone masonry seawall along Hillard Bloom Shellfish, Inc.,
looking south, photo taken March 18, 2016.

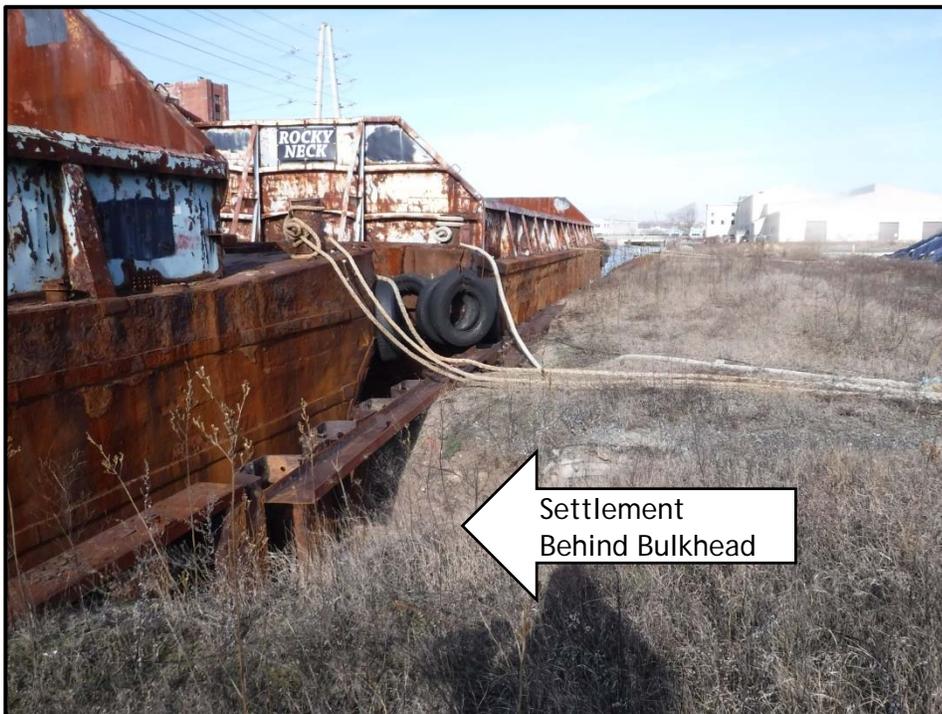
Photo No. 12:
Steel sheet pile bulkhead along Gateway Terminal,
looking north, photo taken January 8, 2016.

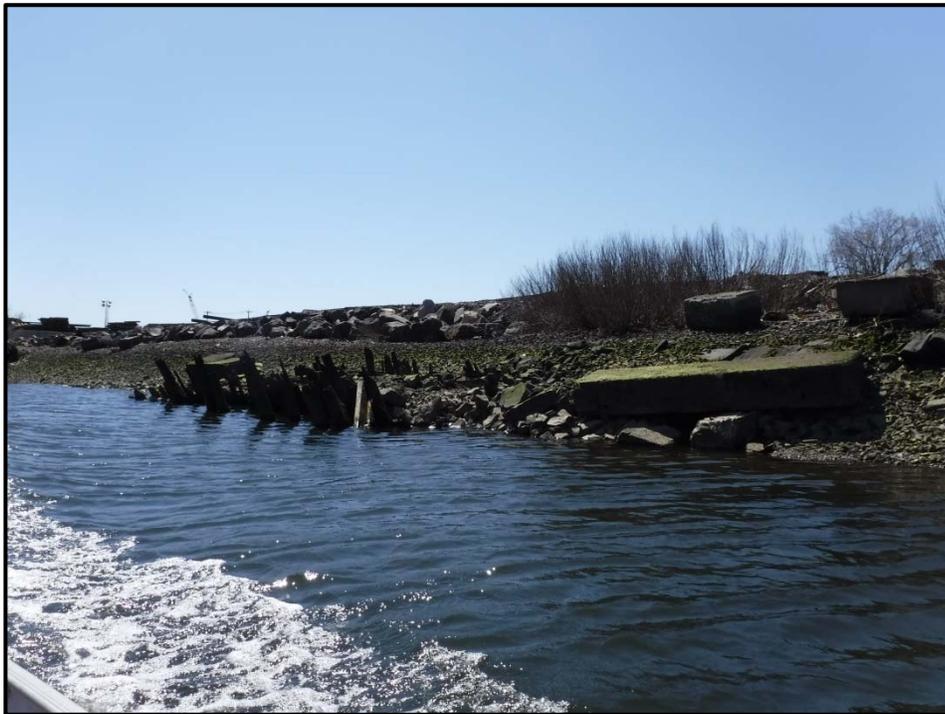
Photo No. 20:
Natural shoreline with riprap at top along former Simkins, looking southwest, photo taken April 14, 2016.

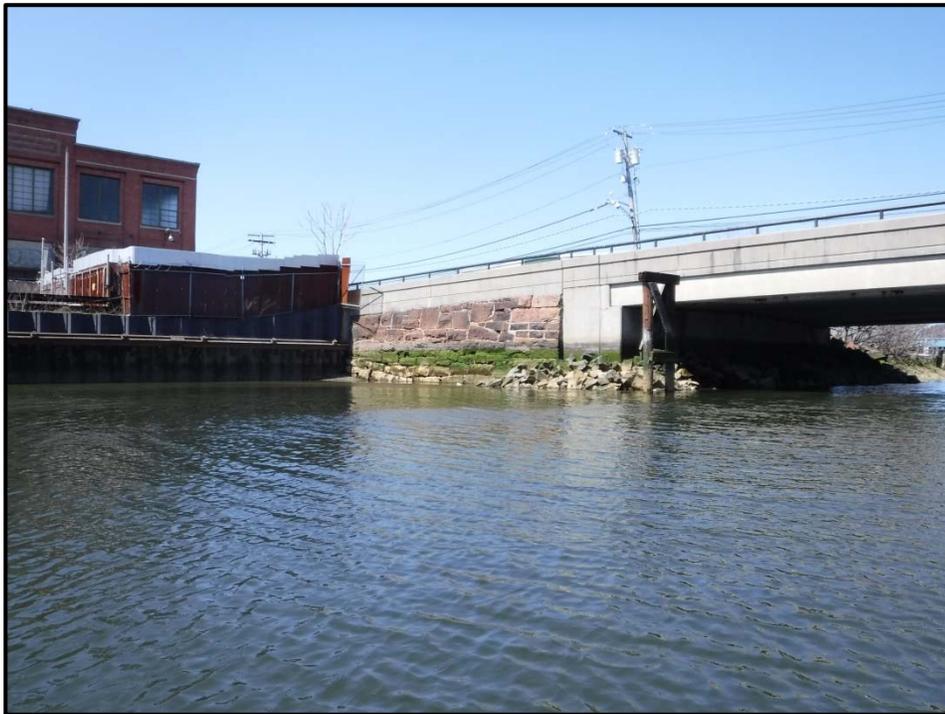
Photo No. 24:
Grand Avenue stone masonry seawall, looking northwest,
photo taken April 14, 2016.

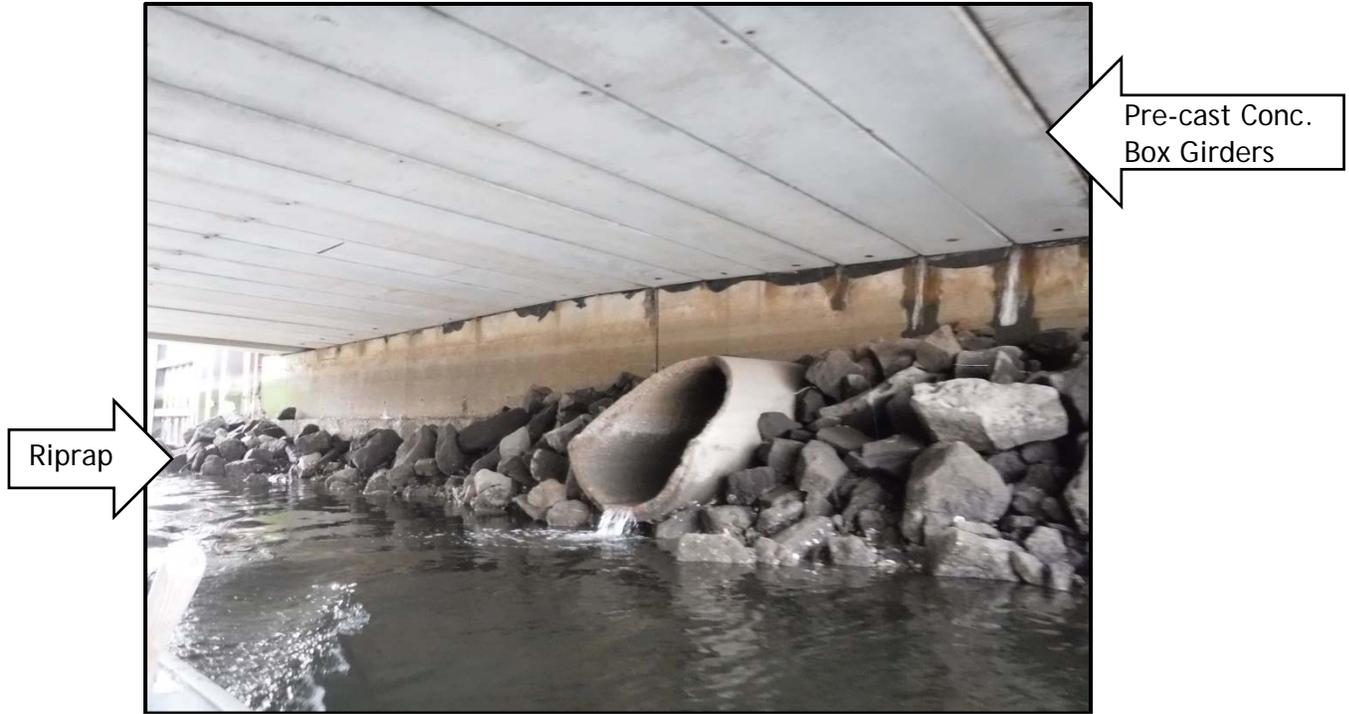
Photo No. 25:
Grand Avenue Bridge over the West Branch of the Mill River, looking west,
photo taken February 19, 2016.

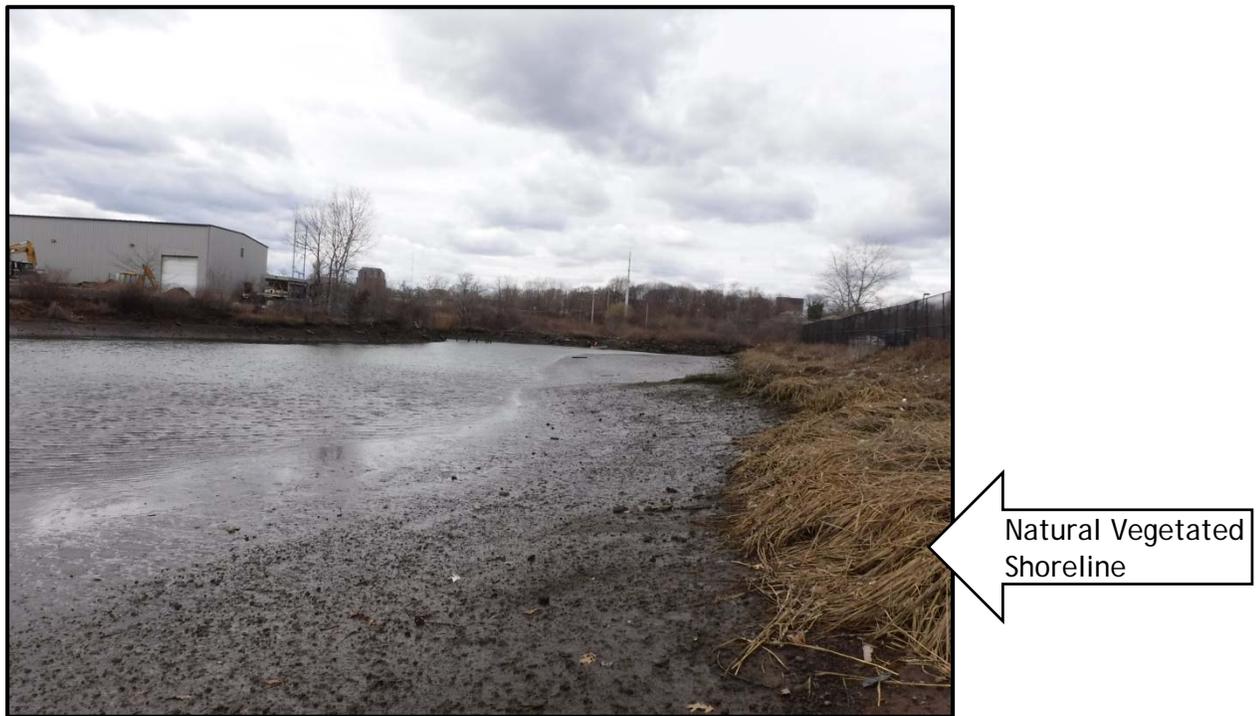
Photo No. 26:
Shoreline along Radiall, looking west,
photo taken March 18, 2016.

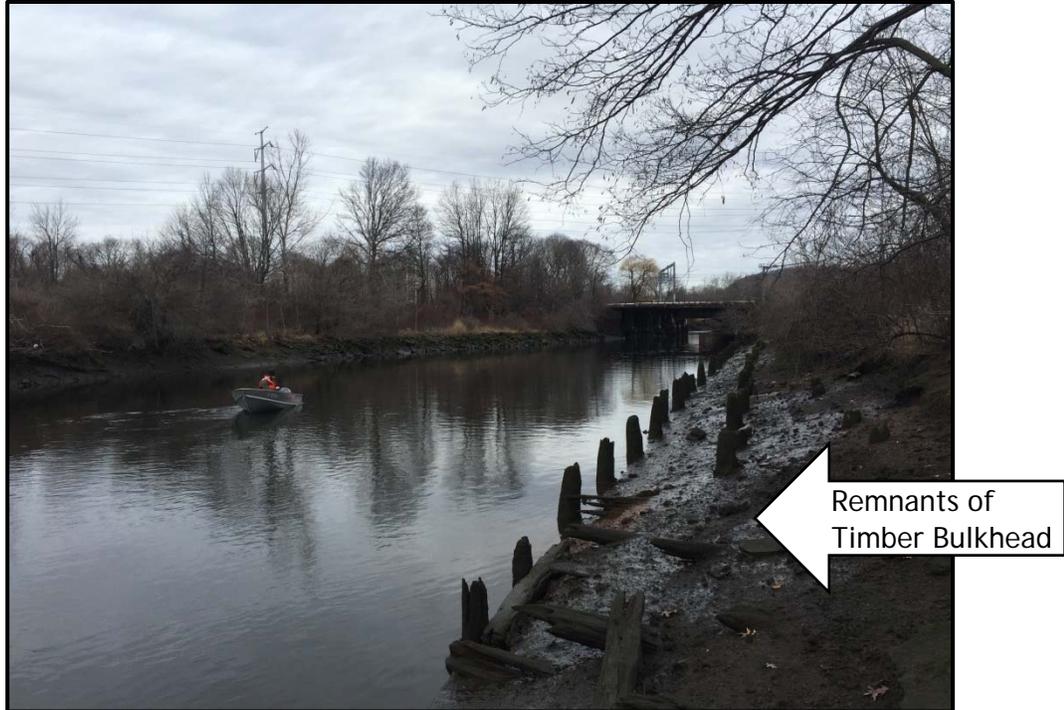
Photo No. 27:
Remnants of a timber bulkhead along Radiall, looking north,
photo taken February 4, 2016.

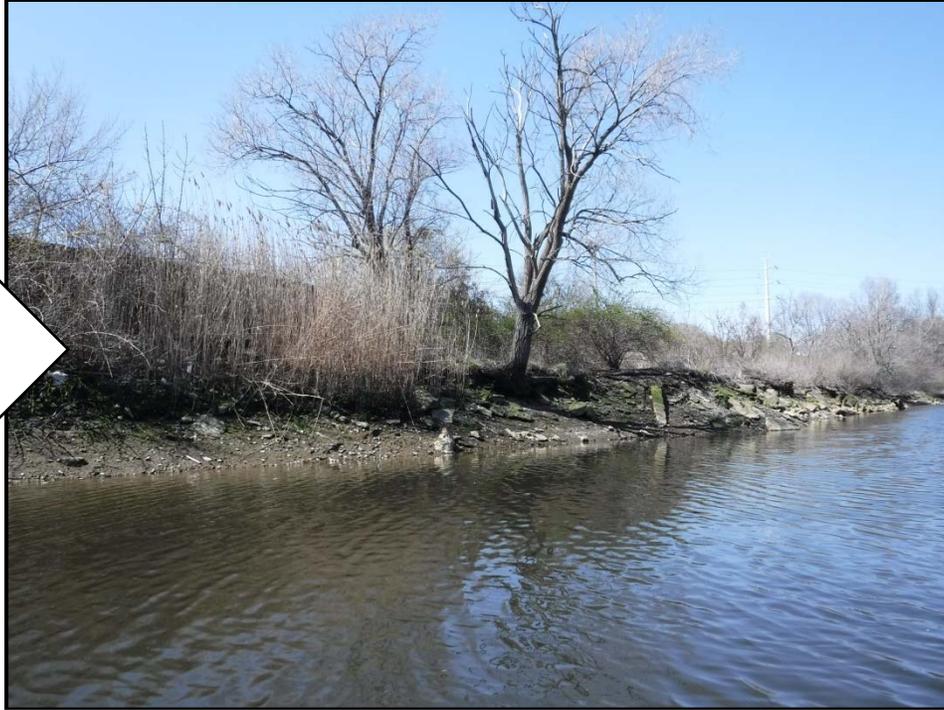
Vegetation at
MHW

Photo No. 31:
Shoreline along former St. Gobain, looking northwest,
photo taken April 14, 2016.

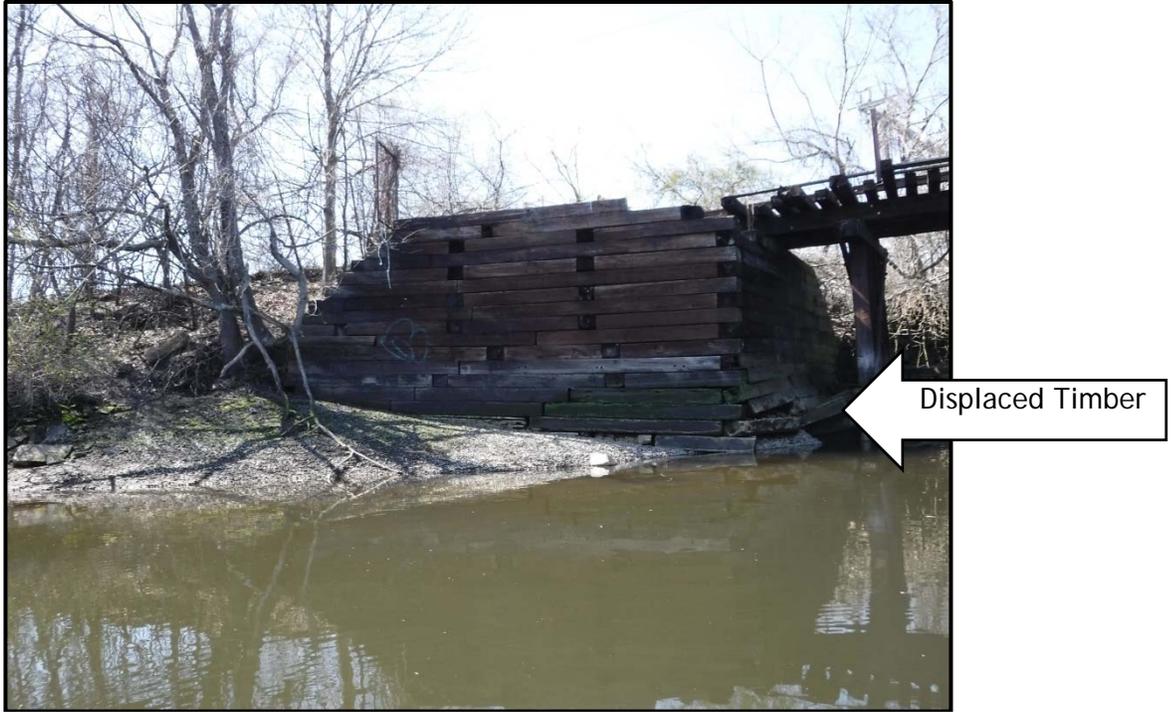
Photo No. 33:
West timber abutment of abandoned rail crossing, looking northwest,
photo taken February 19, 2016.

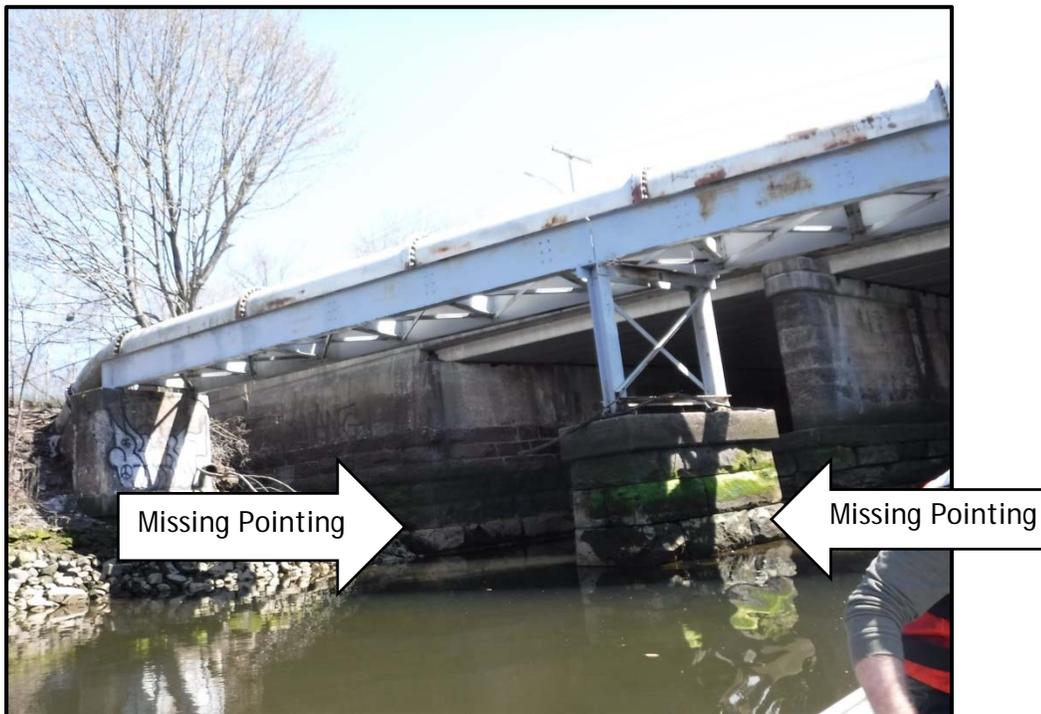
River Crossing	Humphrey Street Bridge (NA)	50+20 - 50+84 (65 lf)	Stone Masonry Abutments	5.0	<ul style="list-style-type: none"> •Bridge consists of concrete girders, decking, and parapets supported by concrete abutments and piers with stone masonry foundations (Photo No. 40). •A steel girder bridge supporting a utility exists immediately north of the bridge and is supported by concrete abutments and steel piers with stone masonry foundations. •Missing pointing and stones was observed in all of the stone masonry foundations.

Photo No. 40:
Humphrey Street Bridge and Utility Bridge over the Mill River,
looking southeast, photo taken April 14, 2016.
