**State of Connecticut
Department of Public Works
165 Capitol Avenue, Room 265
Hartford, Connecticut 06106
Mr. George P. Nakos**

**Property Condition Evaluation
Physical Condition Evaluation Report
of
18-20 Trinity Street
Hartford, Connecticut 06106**

**EMG Project No.: 91954
Date of Report: July 16, 2002
On-site Dates: April 24, 2002**

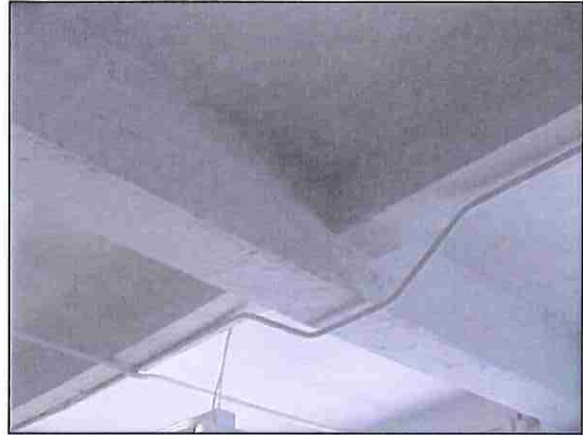
- Significant water damage and surface spalling of the concrete ceiling basement slab below the rear parking area was observed. Repairs are required within the year. As part of this repair, waterproofing and sealing of the lower rear wall at foundation/asphalt pavement transition. The cost of this work is included in the Short Term Repairs Cost Estimate (Table 2).

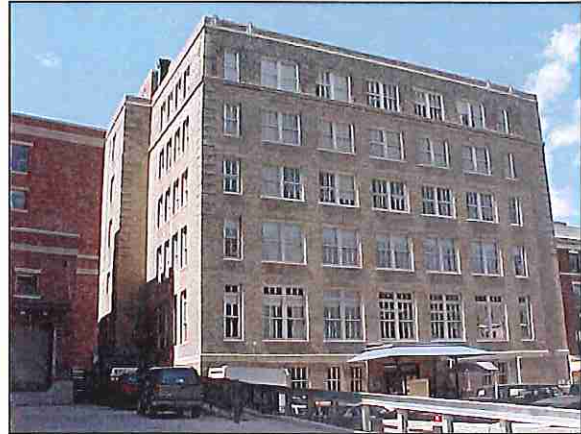
- The brick and stone are in fair to poor condition. A general deterioration of the brick and mortar joints has occurred along the corners of the 6-story portion of the building. Corrosion of the steel lintels was also observed. Temporary repairs and bracing was observed. A detailed *Exterior Wall Investigation Report*, prepared by DuBose Associates Inc. Architects, (included in the appendices of the report), outlines the existing conditions, causes, potential consequences and recommendations for repairs. The recommended repairs should be completed immediately based on the severity of the situations. The cost is included in the Immediate Repairs Cost Estimate (Table 1).
