Southbury Training Farm Various Buildings - Adaptive Reuse Study

Project No. BI-2B-444

January 16, 2019

O’Riordan Migani Architects LLC, 22 Bank Street, Seymour, CT 06483

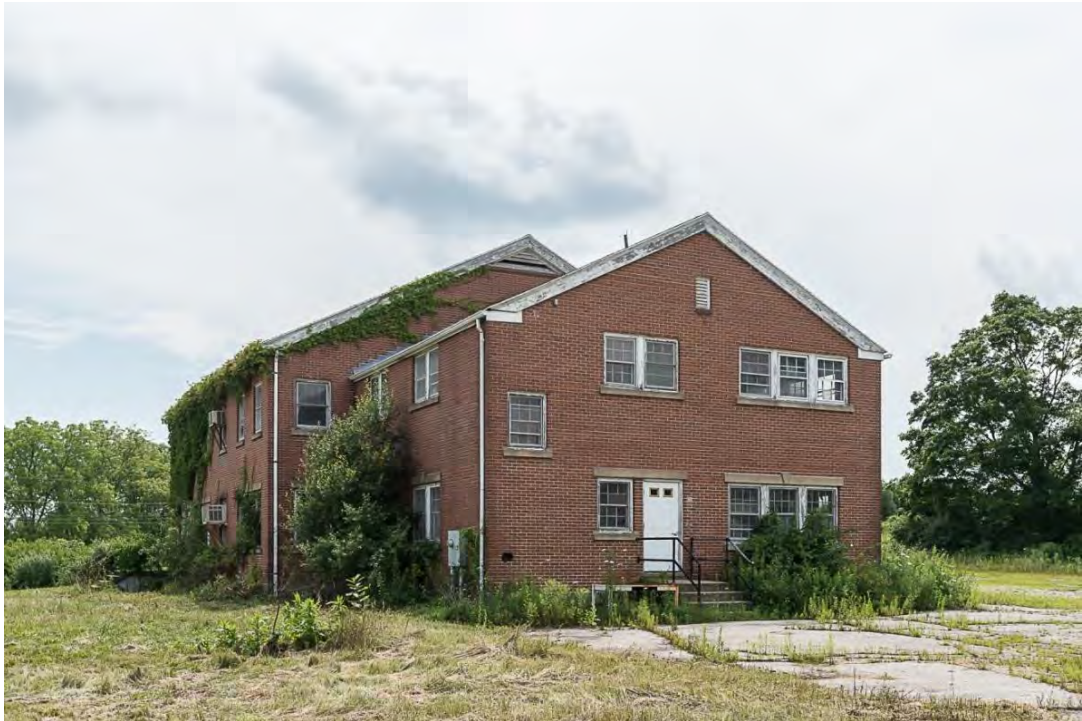
Photo 3. Building 1, view southeast showing north and west elevations.

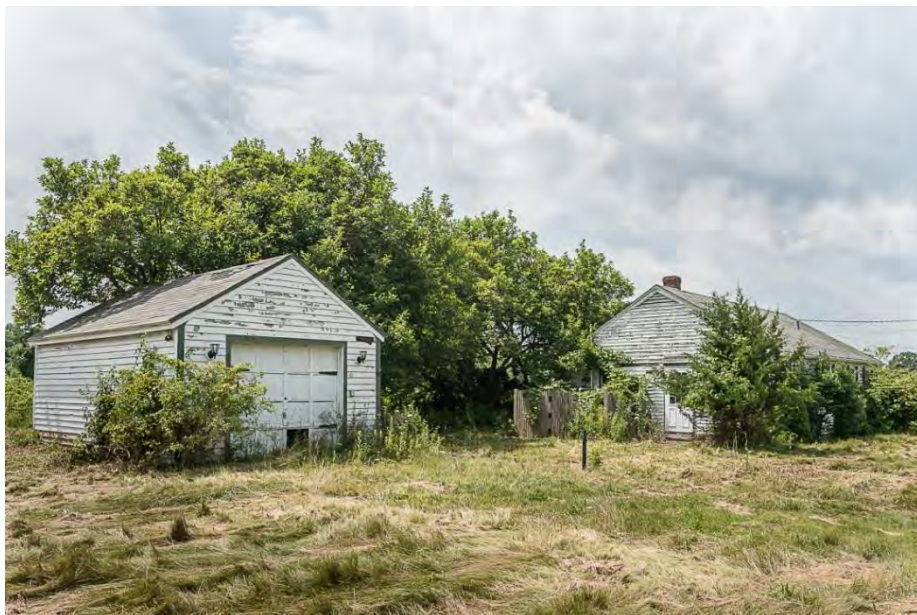
The garage associated with this house was built in 1950 and it is listed as non-contributing the National Register of Historic places nomination because it was built after the 1940 Period of Significance for the nomination. It also has a very high degree of architectural integrity and it is less overgrown than the house. It is in its original location and retains its original siding and side door, but they have not been maintained. The garage door may have been replaced. The interior was inaccessible.

Photo 20. Building 3, view southwest showing east elevation, façade and relationship to house.

12	Building Systems	None
13	Building Utilities	None. An underground power feed/circuit for lights and a GFI duplex receptacle should be refed from the service panel in the house.
14	Other	
15	Accessibility	N/A
16	Record Photos	See Photos No. 20 in Section IV of this report
17	Historic Status	The building was constructed in 1950 and was listed as NON-CONTRIBUTING to the National Register of Historic place nomination because it was built after the end of the 1940 period of significance.

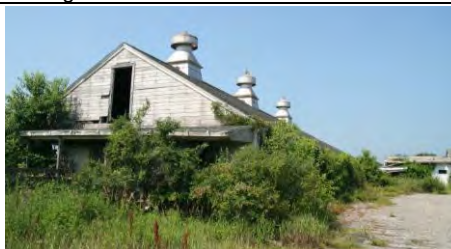
11	Structure	The building is a one story structure with a gable roof style. The building roof consists of 1x6 wood decking and wood trusses spaced approximately at 2'-0" on center. The trusses are supported at four locations, at the perimeter walls and two interior beam support locations, approximately at third points of the width of the building. The perimeter walls are timber framed and bear on a concrete foundation knee wall. The knee wall extends approximately 32 inches above the floor slab. The two interior beam lines are supported by steel pipe columns filled with concrete spaced approximately 10'-0" on center at the east side of the building and by 6x6 timber posts on the west side of the building. At the center of the building there is a lower one-story wood framed connector that links Building 8 with the north side of Building 7. The connector link is wood framed and has major moisture damage. Although majority of the structure is concealed by a wood ceiling, the overall structure appeared to be in good condition. The roof decking and framing that was observed through a small opening in the ceiling appeared to be in good condition. There are no visible signs of sag in the roof ridge from street level and the walls appear to be plumb. The steel pipe column bases are completely deteriorated and the concrete fill is exposed at most of the pipe column locations. These columns should be replaced. Towards the west end of the building, the interior bearing supports were removed and replaced with two shoring jacks. The 6x6 timber posts appear to be in good condition. The concrete floors are in good condition; minor cracking was observed. The wood framing for the connector link to Building 7 has been exposed to moisture and is deteriorated. The connector link should be demolished and replaced.

Reference Photo: East End of Dairy Barn Looking West
