LM6000PC
BORESCOPE INSPECTION (HSE) REPORT
for
191-327

Customer	LS Power
Site	Wallingford
Address	115 John Street Wallingford, CT 06492
Phone	
Contact	David Evinrude
Unit No.	191-327
Engine Model No.	LM6000PC
Engine Serial No.	191-327
Fired Hours	13,478
Fired Starts	629
Inspection Date	April 9, 2018
Field Services Rep	Chris Harris
Job Number	1015-5113

Unit 7 LP Vibration Investigation

Engine Serial Number: 191-346
Engine Model: 7LM6000PC – NGW
Project Number: 1015-5113-346W
Date Started: 03/16/2018
Date Completed: 4/05/2018

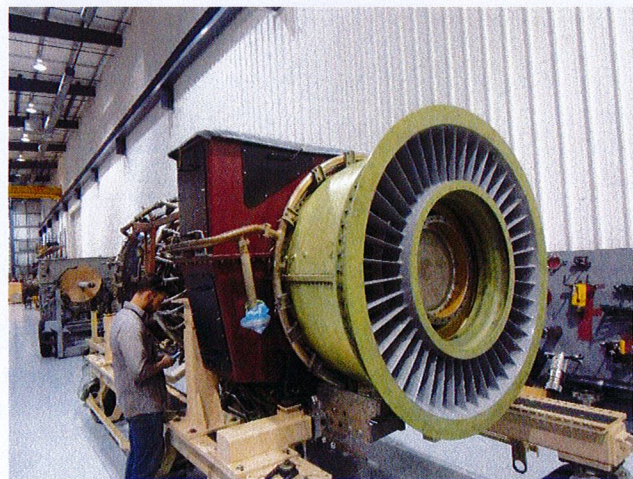
Incoming Photos:

ESN: 191-346 arrived at the Pro Energy Aero Depot on March 15, 2018. The engine was inducted into the Depot and inspected in order to document the as received condition.

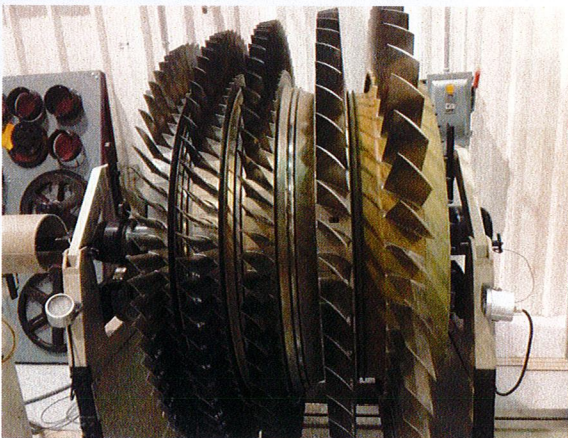
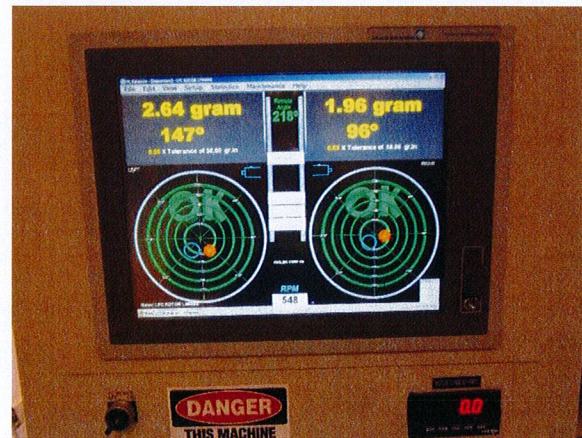
LPCR Pictures:

- LPC Rotor was found to be slightly outside desired balance specifications.

- LPC Rotor rebalanced to tighter specifications. Results shown below.

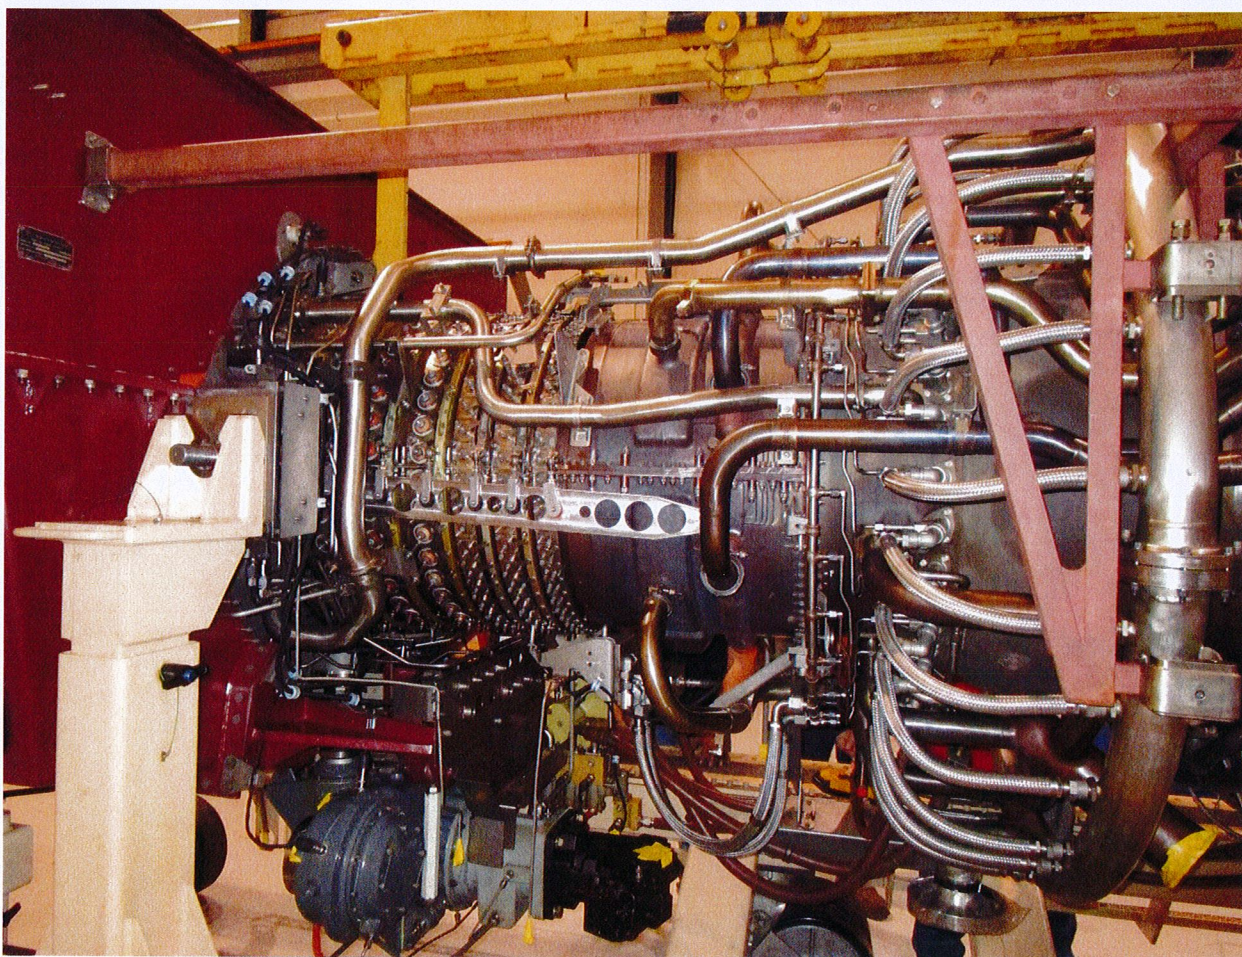
➤ Install External Piping
